## Fatigue strengthening of welds in light rail structures

**London's Docklands Light Railway (DLR) has been in service for 20 years and has previously been strengthened when it was upgraded from one-car trains to two-car trains in 1990. It is now to be upgraded again to carry three-car trains to be run at higher frequencies and is required to have a fatigue life of 120 years from the year 2010, namely for the structures to remain serviceable until the year 2130. Some of the welds connecting stiffeners to main beams, which were found to be under strength in fatigue, were strengthened by ultrasonic impact treatment (UIT). A programme of fatigue tests has been carried out to evaluate the extent of the improvement and confirm that it is adequate. The tests were on tensile test pieces having non-load-carrying fillet welded attachments relevant to the (BS5400 class F2) under strength welds. Test pieces were pre-fatigued to simulate 20 years' service and treated by ultrasonic impact. The UIT improved the class F2 fillet welds to a performance between class D and class E. There is a 97.5% probability that performance is improved by a factor of 3 on life and the value of  $\sigma_0$  (the

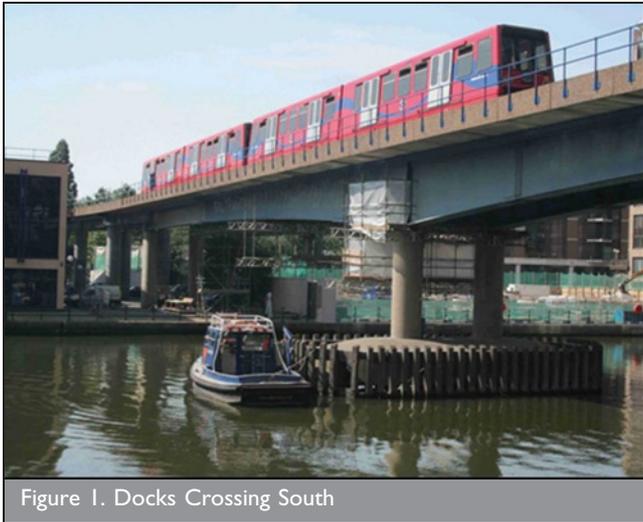
Figure 1. Docks Crossing South

The object of the work was to evaluate the improvement achieved by UIT and derive a safe design criterion. The structures requiring improved fatigue performance for this project were Docks Crossings South, Middle and North. Docks Crossing South is shown in Figure 1.

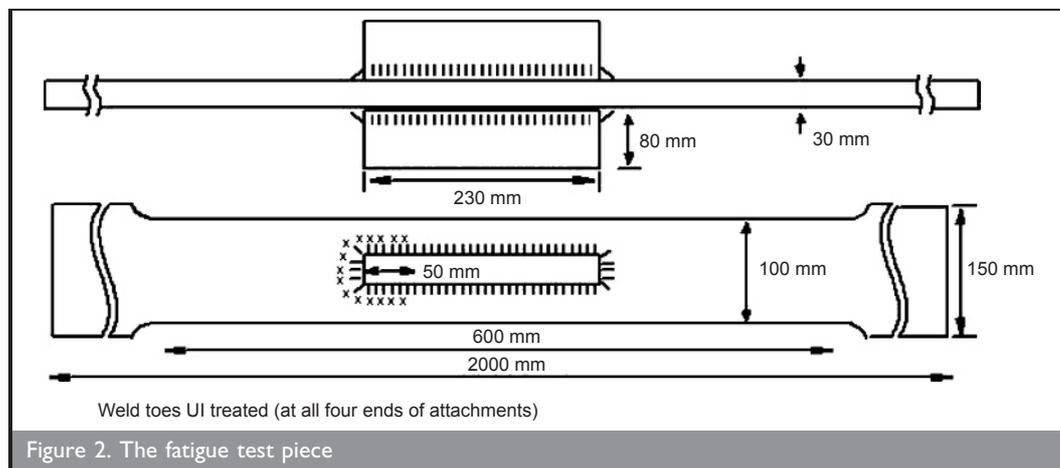
Figure 2. The fatigue test piece

The testing programme was designed to be fully compatible with the earlier work. Uniaxial test pieces were fabricated from 30 mm thick steel plate complying with BS EN 10025:2004 grade 255J2 (BSI, 2004). Non-load-carrying stiffeners were attached with 8 mm leg fillet welds completed in three passes, as shown in Figure 2. This design of test piece has a Class F2 fatigue classification and was selected because it has well publicised properties and has been used in many investigations in the past. Moreover, it was used in support of the earlier upgrade of DLR structures (Maddox, 1997).

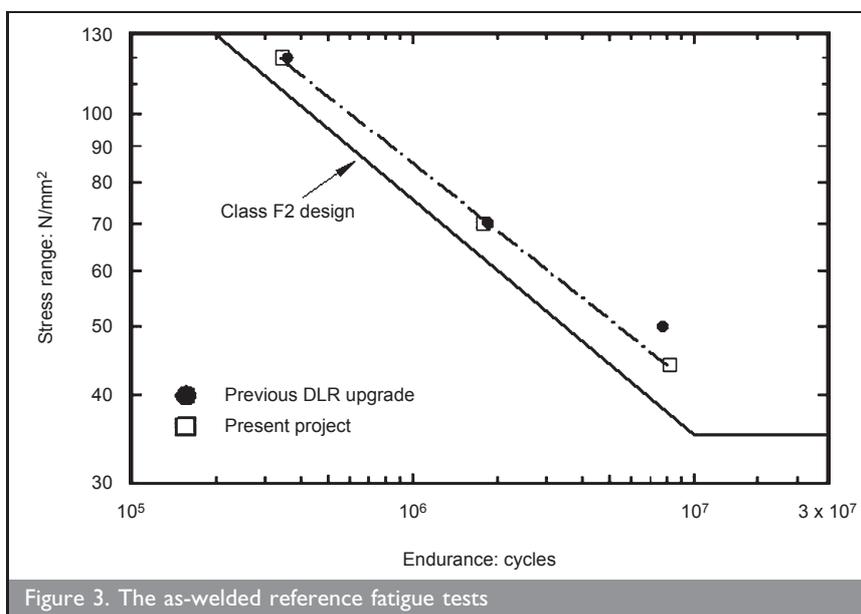
Figure 3. The as-welded reference fatigue tests

The fatigue performances of the as-welded test pieces correlated closely with the earlier work and confirmed that the two programmes of testing were compatible, as shown in Figure 3. It was therefore possible to establish the reference *S-N* fatigue curve from a small number of tests. During the tests it was observed that cracking at the weld toe occurred within 10% of the eventual life to failure.

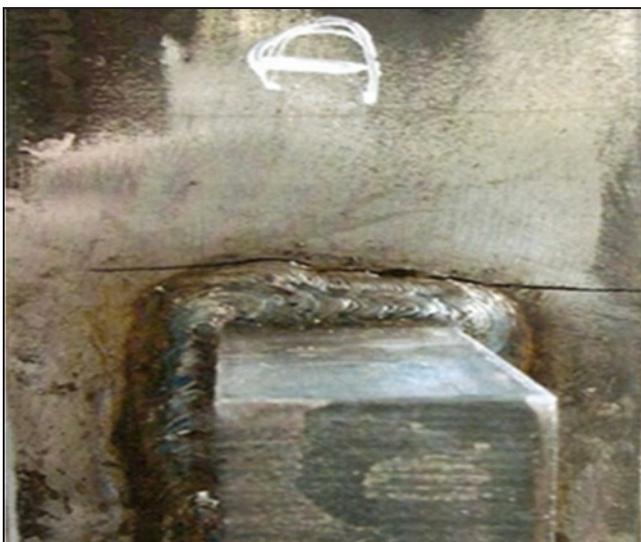
Figure 5. Fatigue crack from weld toe and into main plate of an as-welded test piece

The as-welded test pieces failed from cracks that initiated at the weld toes at one end of the stiffener and propagated through the parent plate, as shown in Figure 5. It was also found that cracking had initiated at the weld root and in two cases propagated through the throat but did not reach the stage when failure was threatened.

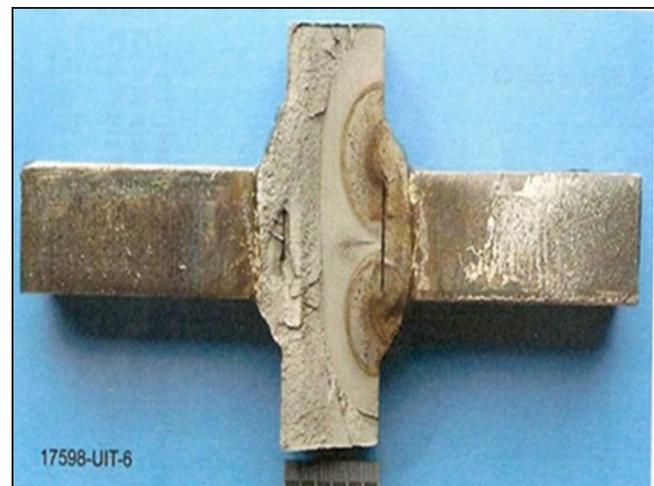
Figure 6. Fatigue crack from root and into main plate of a pre-fatigued and treated test piece.

Examination of the fractures on the pre-fatigued and treated test pieces confirmed that the UIT was effective in halting propagation of cracks that had been initiated at the weld toes. The eventual mode of failure was the same in every case, consisting of crack growth from the weld root through the throat and finally through the parent plate, see Figure 6. This was the same as occurred in the earlier tests on hammer-peened welds. In the case of the long-running test that survived  $2 \times 10^7$  cycles without failure, it was subsequently found that cracking had initiated in the weld throat at one end of the stiffener to an extent that implied that it had reached an endurance estimated to be between 50 and 90% of life. This provides added support to the conservative decision to treat the run-out as a failure.

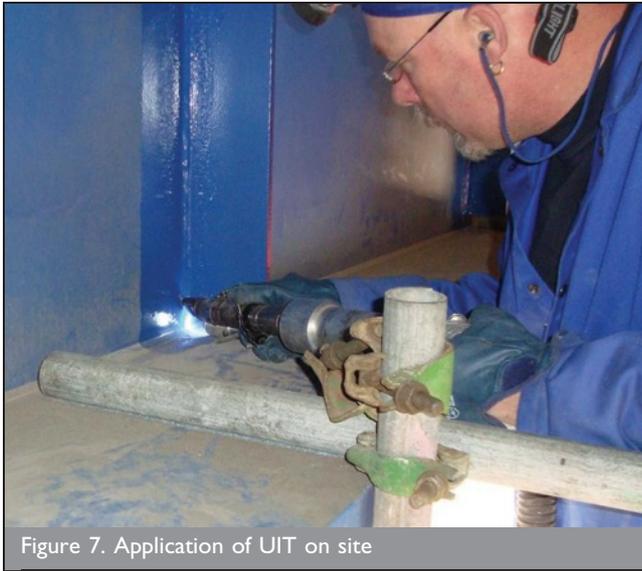
Figure 7. Application of UIT on site

The welds found to require treatment were inspected for the presence of cracking as it was considered that although the tests had demonstrated that UIT successfully strengthened welds having cracks of up to 8 mm in surface length, it would not be appropriate to treat longer cracks. In the event, no fatigue cracks were found even in locations where the assessment indicated a low remnant fatigue life. After inspection, paint was removed from the weld toes by use of a needle gun and wire brush grinders, taking great care to collect the detritus and prevent anything from dropping below the viaducts. The UI treatment was applied along the toe of the weld at the transition of the weld material and base material, as shown in Figure 7. The tool

was continuously moved back and forth and progressively forward in a path parallel to the direction of the weld toe. The site work was carried out under live load conditions.

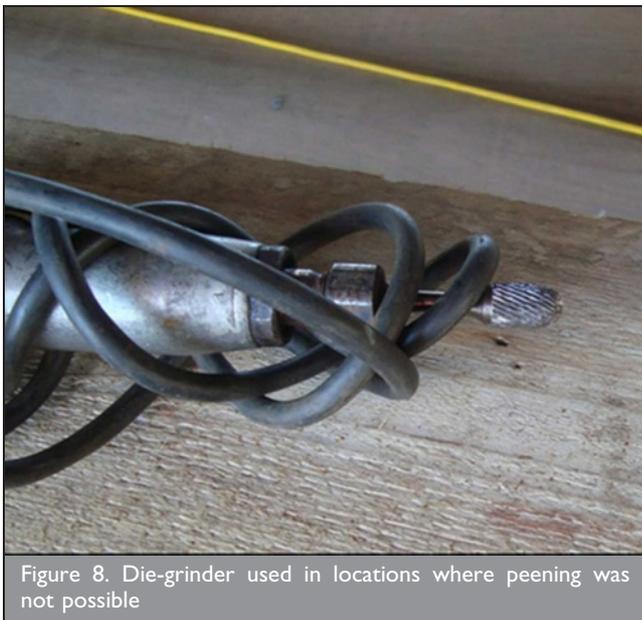
Figure 8. Die-grinder used in locations where peening was not possible

Some of the welds would have been impossible to access for hammer-peening and were difficult even with the more accommodating UIT equipment. In these cases a modified UIT tool was used that had an extended head to give it greater flexibility around the bases of the stiffeners. Where bolted connections were close to the web stiffener this would not have been sufficient and on confirmation of the remaining fatigue life, these areas were treated using a die-grinder as shown in Figure 8. An example of a stiffener weld requiring die-grinding is shown in Figure 9.

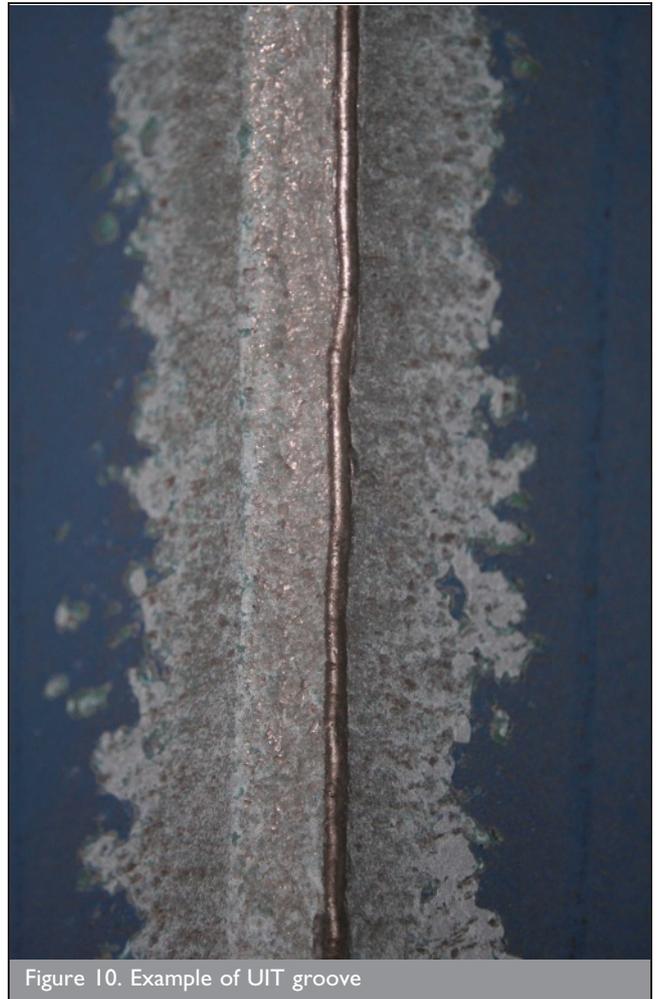
Figure 10. Example of UIT groove

- (a) The nature and appearance of a properly formed shiny groove at the weld toe was the main evidence that the UI

treatment had been correctly applied, as shown in Figure 10.

- (b) The groove should be clearly visible as a continuous shiny pathway.
- (c) The groove should be uniformly smooth after treatment, centred on the weld toe, and no less than 25% over the weld metal.
- (d) The groove should be homogeneous, uninterrupted and free of any remaining traces of the weld toe.
- (e) There should be no evidence of digging, undercut or other linear indications visible in the centre of the UI-treated area.
- (f) The dimensions of the groove should be in the range 3–5 mm wide and 0.3–0.6 mm deep. This was checked using plasticine moulds which were then measured with calibrated vernier callipers.
